Padre Isles bacterial testing. June 2019.

The following summarizes the results of bacterial testing of select waters in the canals of Padre Isles subdivision, Corpus Christi, Texas as a result of a malfunctioning sanitary sewer line which allowed an overflow of raw sewage through a manhole which subsequently entered a canal via a storm drain. The incident occurred about midday on June 3, 2019, near the intersection of Gypsy and Atascadera avenues.

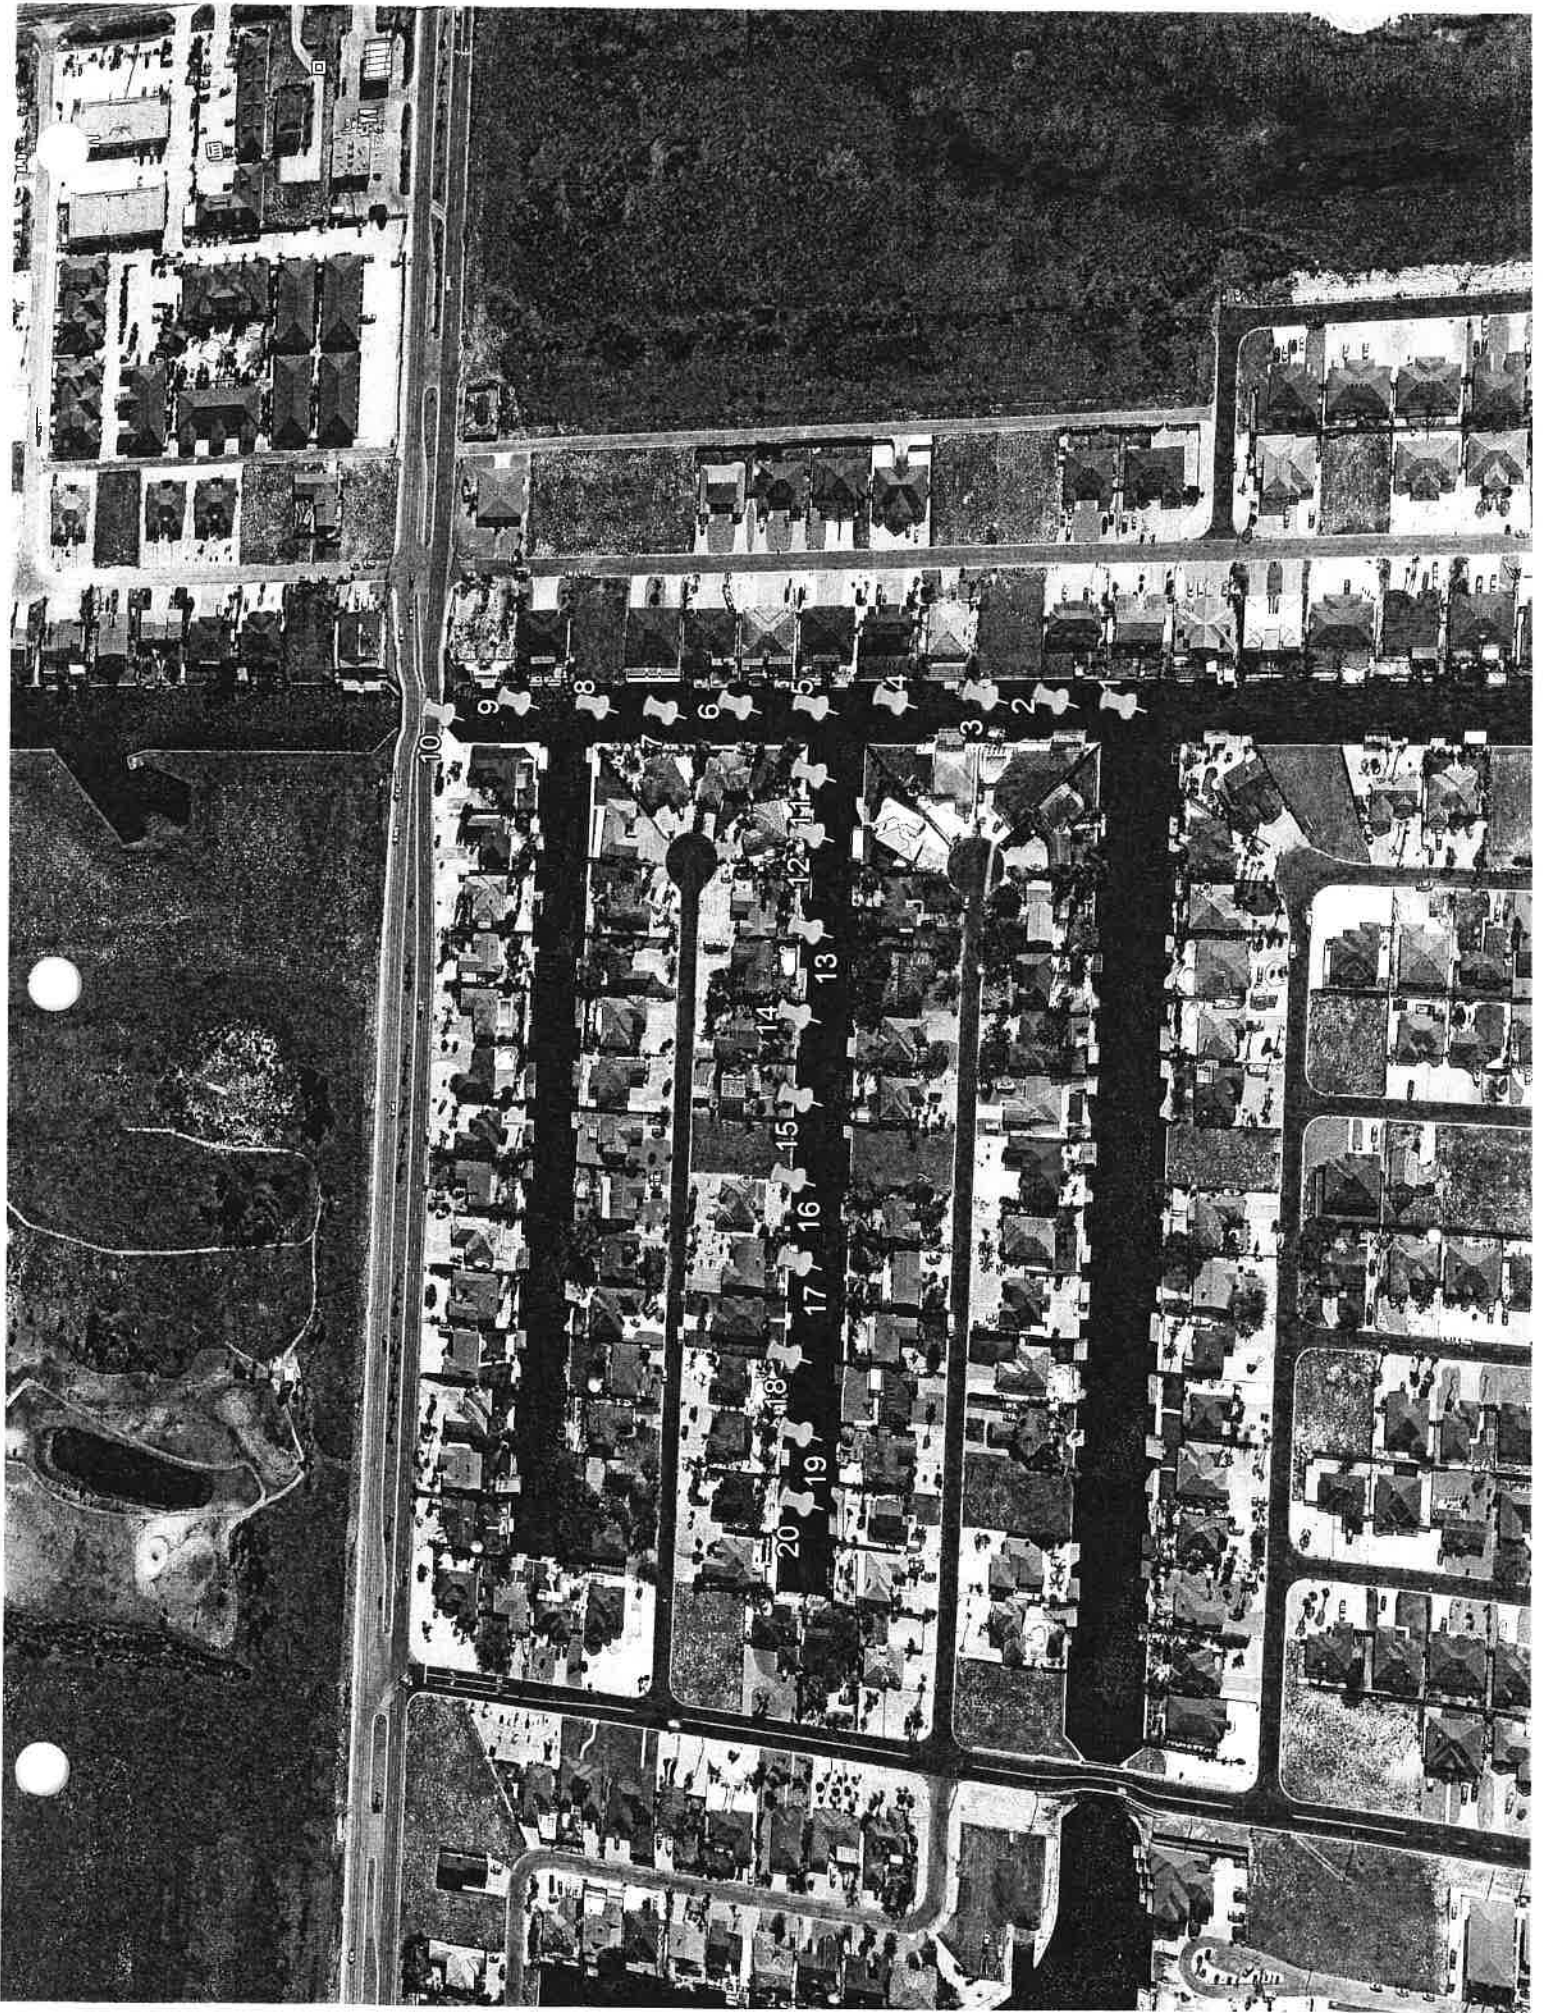
The sewer line was unclogged by City of Corpus Christi Utility crews by mid-afternoon. None of the crew interviewed could provide an estimate of the volume of overflow but did state that they were sure the overflow drained into only a single canal based on ammonia readings taken that afternoon in the nearby canals. The indicated canal was the one behind the homes on Atascadera and Bounty Avenues, which intersects with the canal behind Cuttysark and Cruiser Streets. These canals are indicated on the accompanying map showing sampling locations.

The following are data from two sampling dates, June 11 and 15, 2019. Numbers refer to sampling locations on the accompanying map. Samples were divided into two groups 1-10, and 11-20 for statistical analyses (i.e., calculating the geometric mean). Date. Location-colonies/100 ml sample
